Occupational Radiation Safety

Significance Determination Process

Occupational Radiation Safety Significance Determination Process

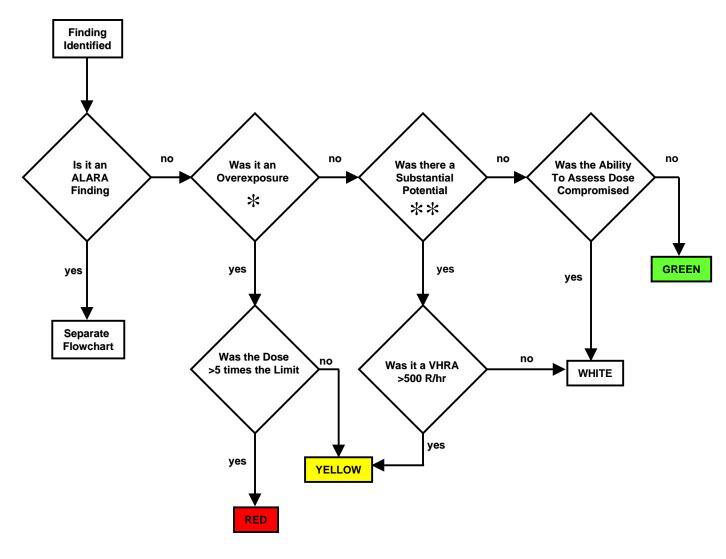
•A possible Inspection Finding is processed through the SDP flowchart

- •The result will be either GREEN WHITE YELLOW

or RED depending on the magnitude of the Dose Equalivent exposure,
 the potential for more serious consequences or the licensee's ability to assess dose
- •The Significance of the PI was based solely on the number of occurrences, irrespective of their severity
- •The SDP evaluates the Significance of Inspection Findings based on the magnitude of actual or potential doses

- * If it is an overexposure attributable to a DRP (Hot Particle) in excess of the OE enforcement discretion (75 μ Ci-hr), then the finding is WHITE.
- ** There is no Substantial Potential for Overexposure (SPO) Finding for a DRP. Such a possibility is outside the scope of the SDP.
